# Mobile Intel® Pentium® 4 Processor-M

Specification Update

*November 2004*

Document Number: **250721-027**

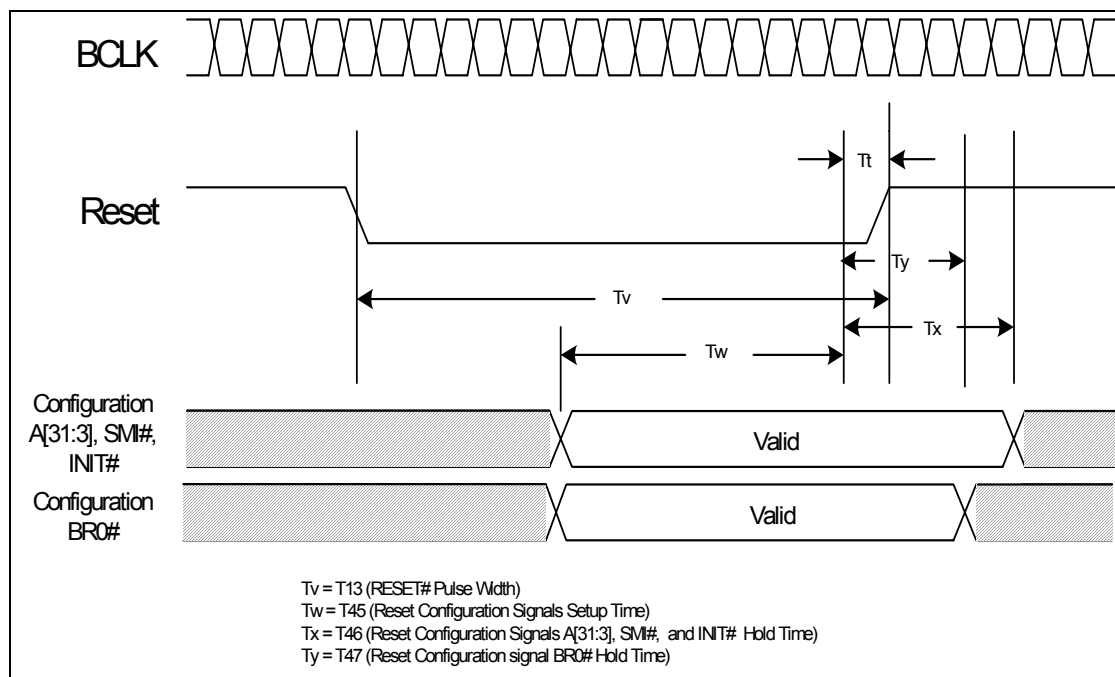
**Figure 13. System Bus Reset and Configuration Timings**

The BR0# maximum hold time has changed to 2 BCLKs. This change will be shown in the “System Bus AC Specifications (Reset Conditions)” table and “System Bus Reset and Configuration Timings” figure of the *Mobile Intel® Pentium® 4 Processor - M Datasheet*. This change will be incorporated in the next revision of the datasheet.
